DEFENCE RESEARCH ESTABLISHMENT OTTAWA

DREO TECHNICAL NOTE NO. 77-3
DREO TN 77-3

NICKEL/CADMIUM AIRCRAFT BATTERIES: SINGLE SENSOR TEMPERATURE MONITORING

PROJECT NO.
54-83-87

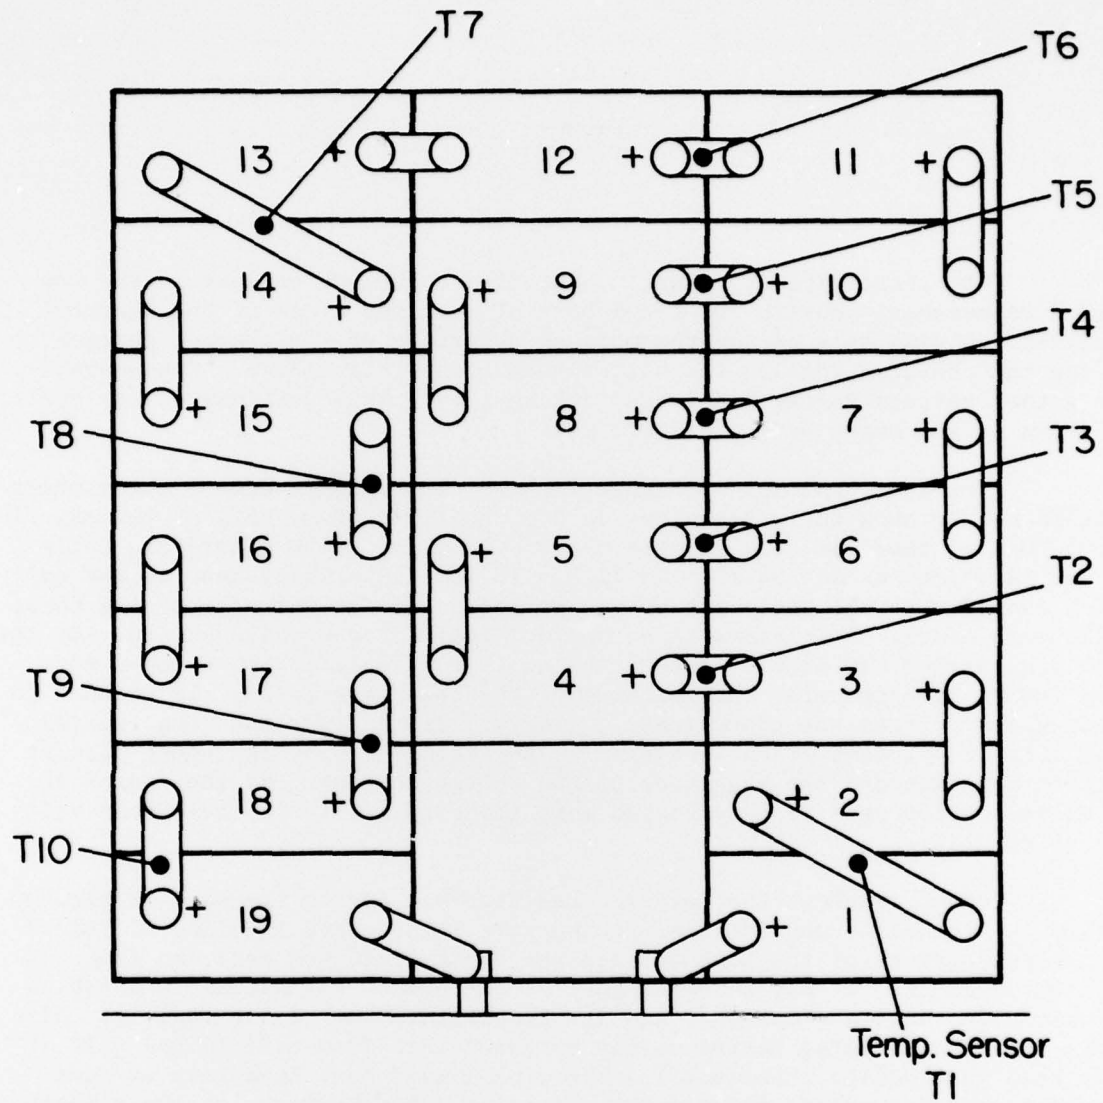
Fig. 1: Cell and Temperature Sensor Locations.

A battery was made up of deteriorated cells to give a high probability of failure. A data logger was used to periodically scan all cell voltages, the total battery voltage, and the temperature of ten intercell current conducting links. The temperature sensors were thermocouples taped to the mid-points of the links with Mylar tape. The locations of these sensors are indicated in Figure 1.

The lower portion of Figure 2 shows the voltages across three cells singled out to show their behaviour during the final 50 minutes of the experiment. One of these is cell 13, the one which failed. The others are cells 12 and 14 which, as may be seen in Figure 1, were physically near to the cell which failed. At the beginning of the period shown the voltages of the three cells were nearly identical with no obvious indication of malfunction. By the next scan period, 10 minutes later, the voltage of cell 13 had dropped more than 160 millivolts below the voltages of the other two cells. In another 10 minutes its voltage was approximately 1.4V. This is lower than the initial open circuit voltages of the other cells so indicates that the short circuit current now exceeded the magnitude of the charge current. By the end of the 50 minute period cell 13 had dropped more than 300 millivolts below the voltage of cell 12.

The curves labelled T3, T6 and T8 in Figure 3 indicate temperatures of various other links (see Figure 1). All show a slight rise in temperature. This rise is typical of the behaviour observed during earlier cycles before the short circuit developed. Furthermore, there is little temperature difference between T3 and T6 or T8. It may be noted that the T6 link is connected to cell 12 whose end wall contacts the end wall of the short circuited cell, while T3 is remote from that cell. Thus during the critical period,

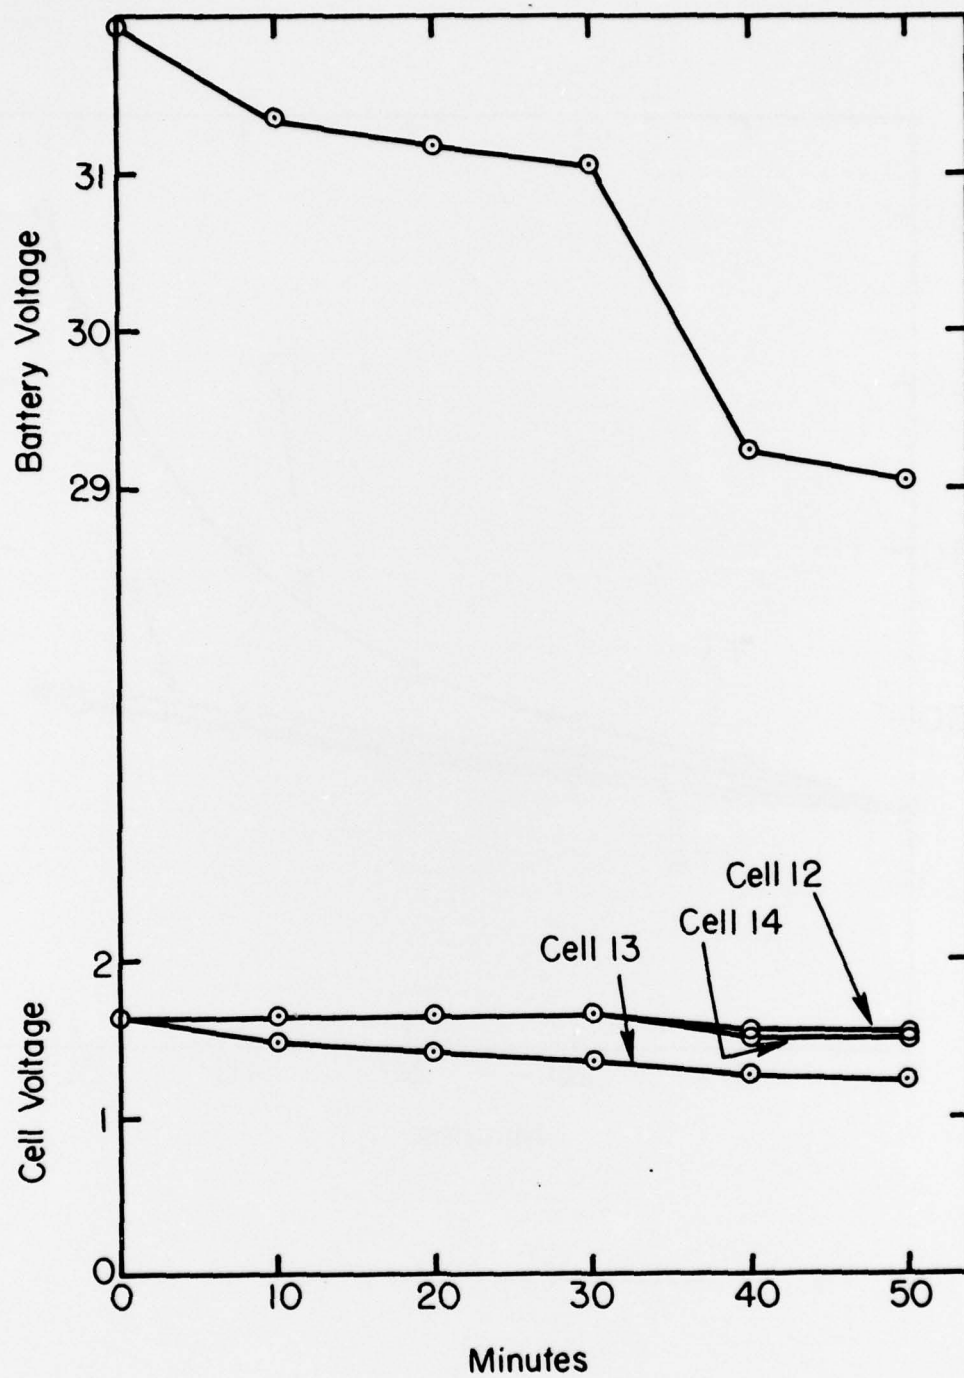
Fig. 2: Voltages During the Final 50 Minutes.

The short circuit in cell 13 started to become evident in the recorded measurements during the final hour of a charge cycle of the Charger-Analyzer. During this period the mode of operation of the charger changes to reduce the charging rate as the battery nears its full charge. Consequently, the actual battery voltage decreases during these final portions of the cycle, as shown in the upper part of Figure 2.

It may be noted that in this experiment the voltage of the shorting cell had already dropped by 160 millivolts relative to the other cells, about 40 minutes before termination of the experiment. This drop is far more than is necessary to trigger the battery alarm unit recently developed at DREO (2).

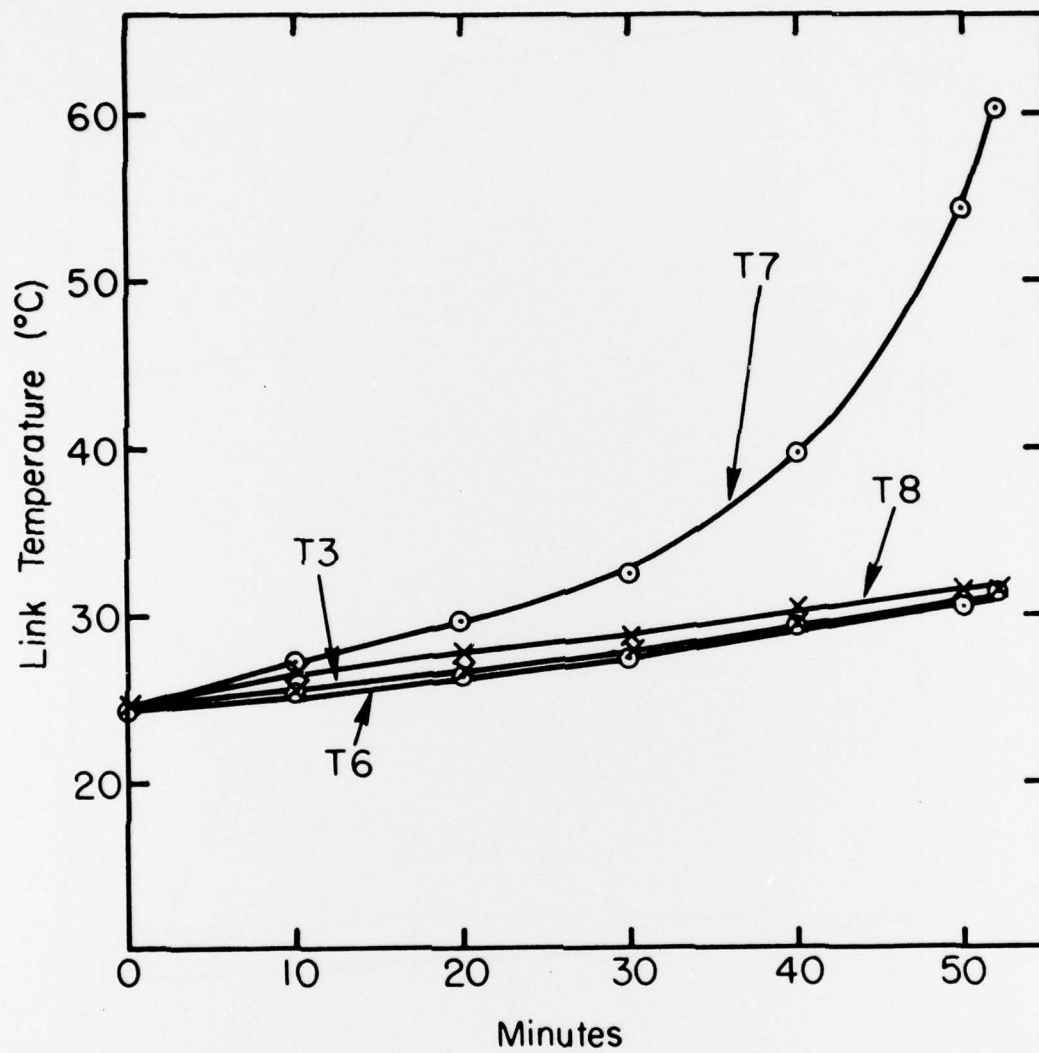
Fig. 3: Temperatures During the Final 50 Minutes.

Figure 3 shows the temperatures recorded during the same 50 minutes period on four different intercell connectors. The curve labelled T7 refers to the temperature of the link between the short circuited cell and the adjacent cell 14. It may be noted that at the end of the period in question the link had reached about 60°C and its temperature was rising rapidly. Also, since cell 14 was being heated mainly by conduction from cell 13 and must have been much cooler than cell 13, the link itself must have been at some temperature intermediate between the two cells. Furthermore, at the time the experiment was terminated (cell 13 was disconnected, removed from the battery and immersed in cold water) steam-like vapour was issuing from the vent of the failed cell and presumably the electrolyte was close to its boiling temperature.

insufficient heat was transmitted to the adjacent cells to raise their temperature significantly.

It is obvious from the above experiment that the temperature of a link does not rise significantly in a moderately short time as a result of internal heating of a remote cell. A single temperature sensor system is therefore not a suitable device with which to warn of a rapidly developing internal short circuit. An effective warning system based on temperature measurement would require temperature sensors on alternate links or in some other series of locations to enable temperatures of all cells to be monitored more or less directly.
